Aircraft Crash - London Heathrow Airport

17th January 2008 at 12.42 pm

Boeing 777-236 G-YMMM

Speedbird 038 PEK - LHR

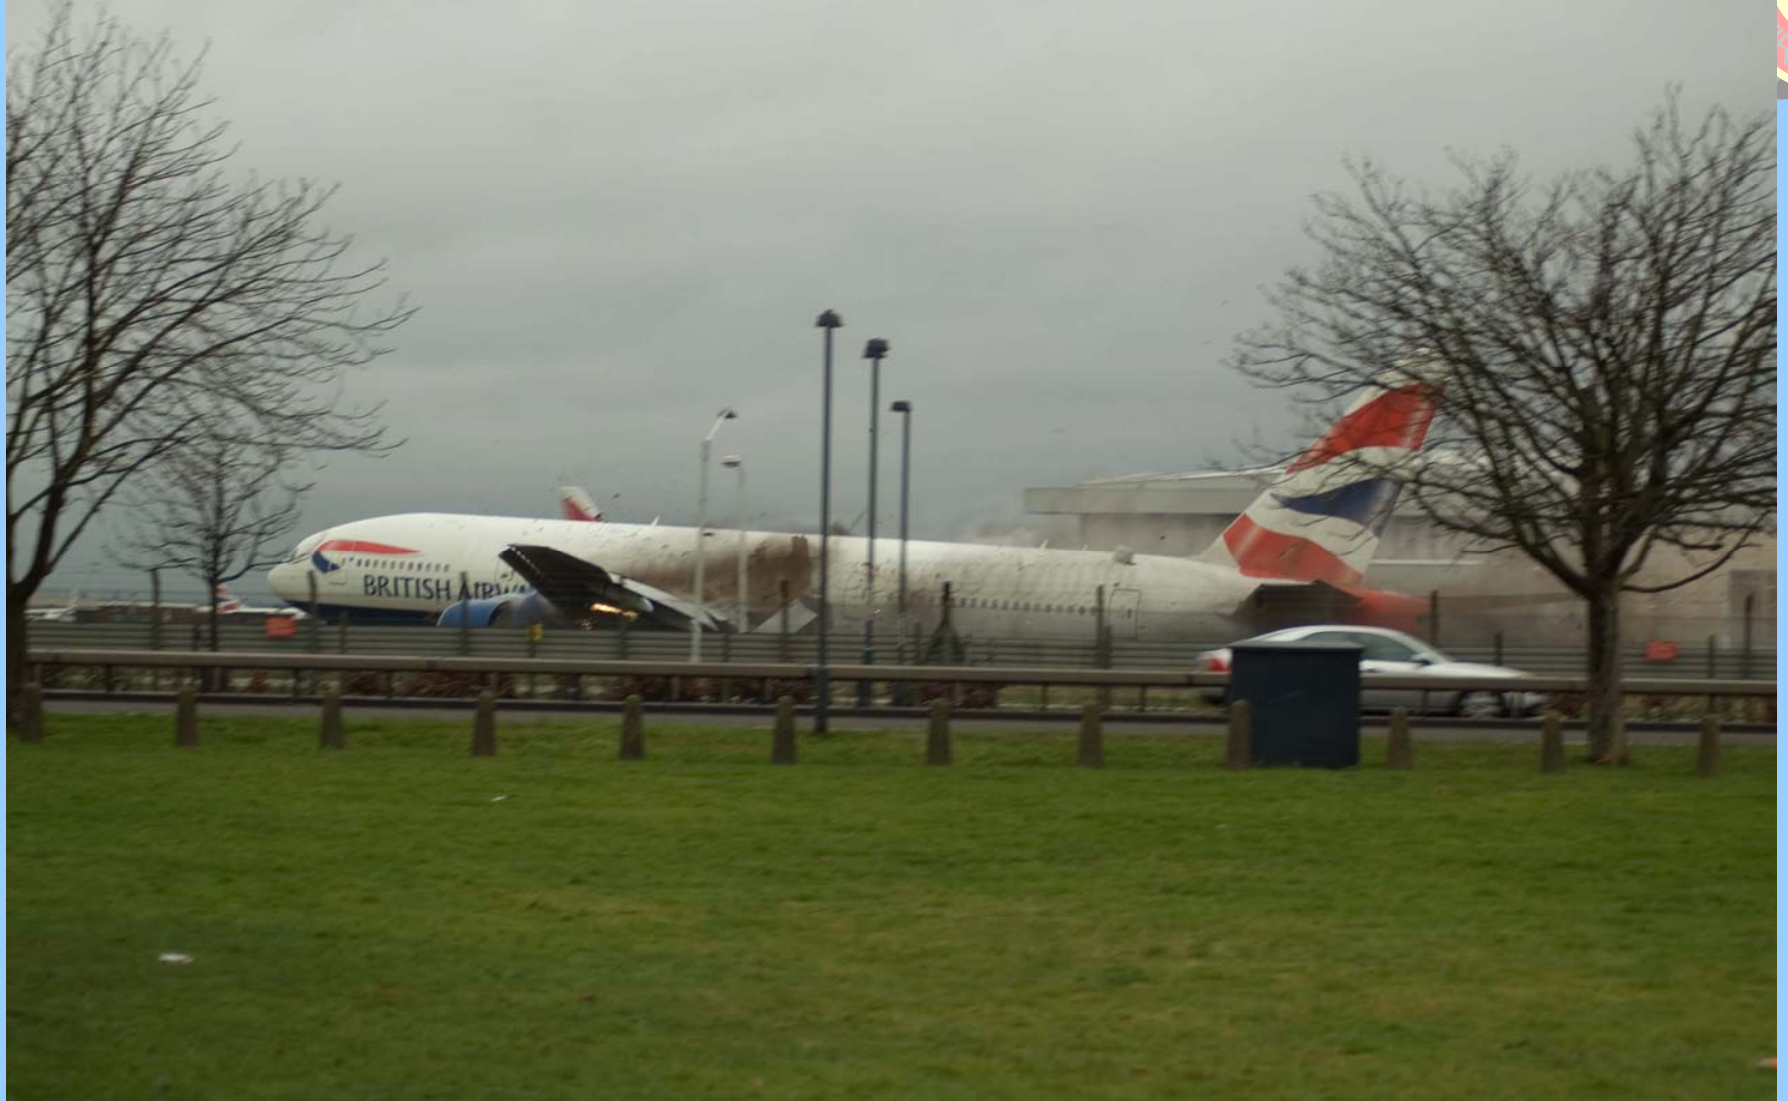
With the airspeed decaying, the aircraft descended rapidly and struck the ground, some 1,000 ft short of the paved runway surface, just inside the airfield boundary fence.

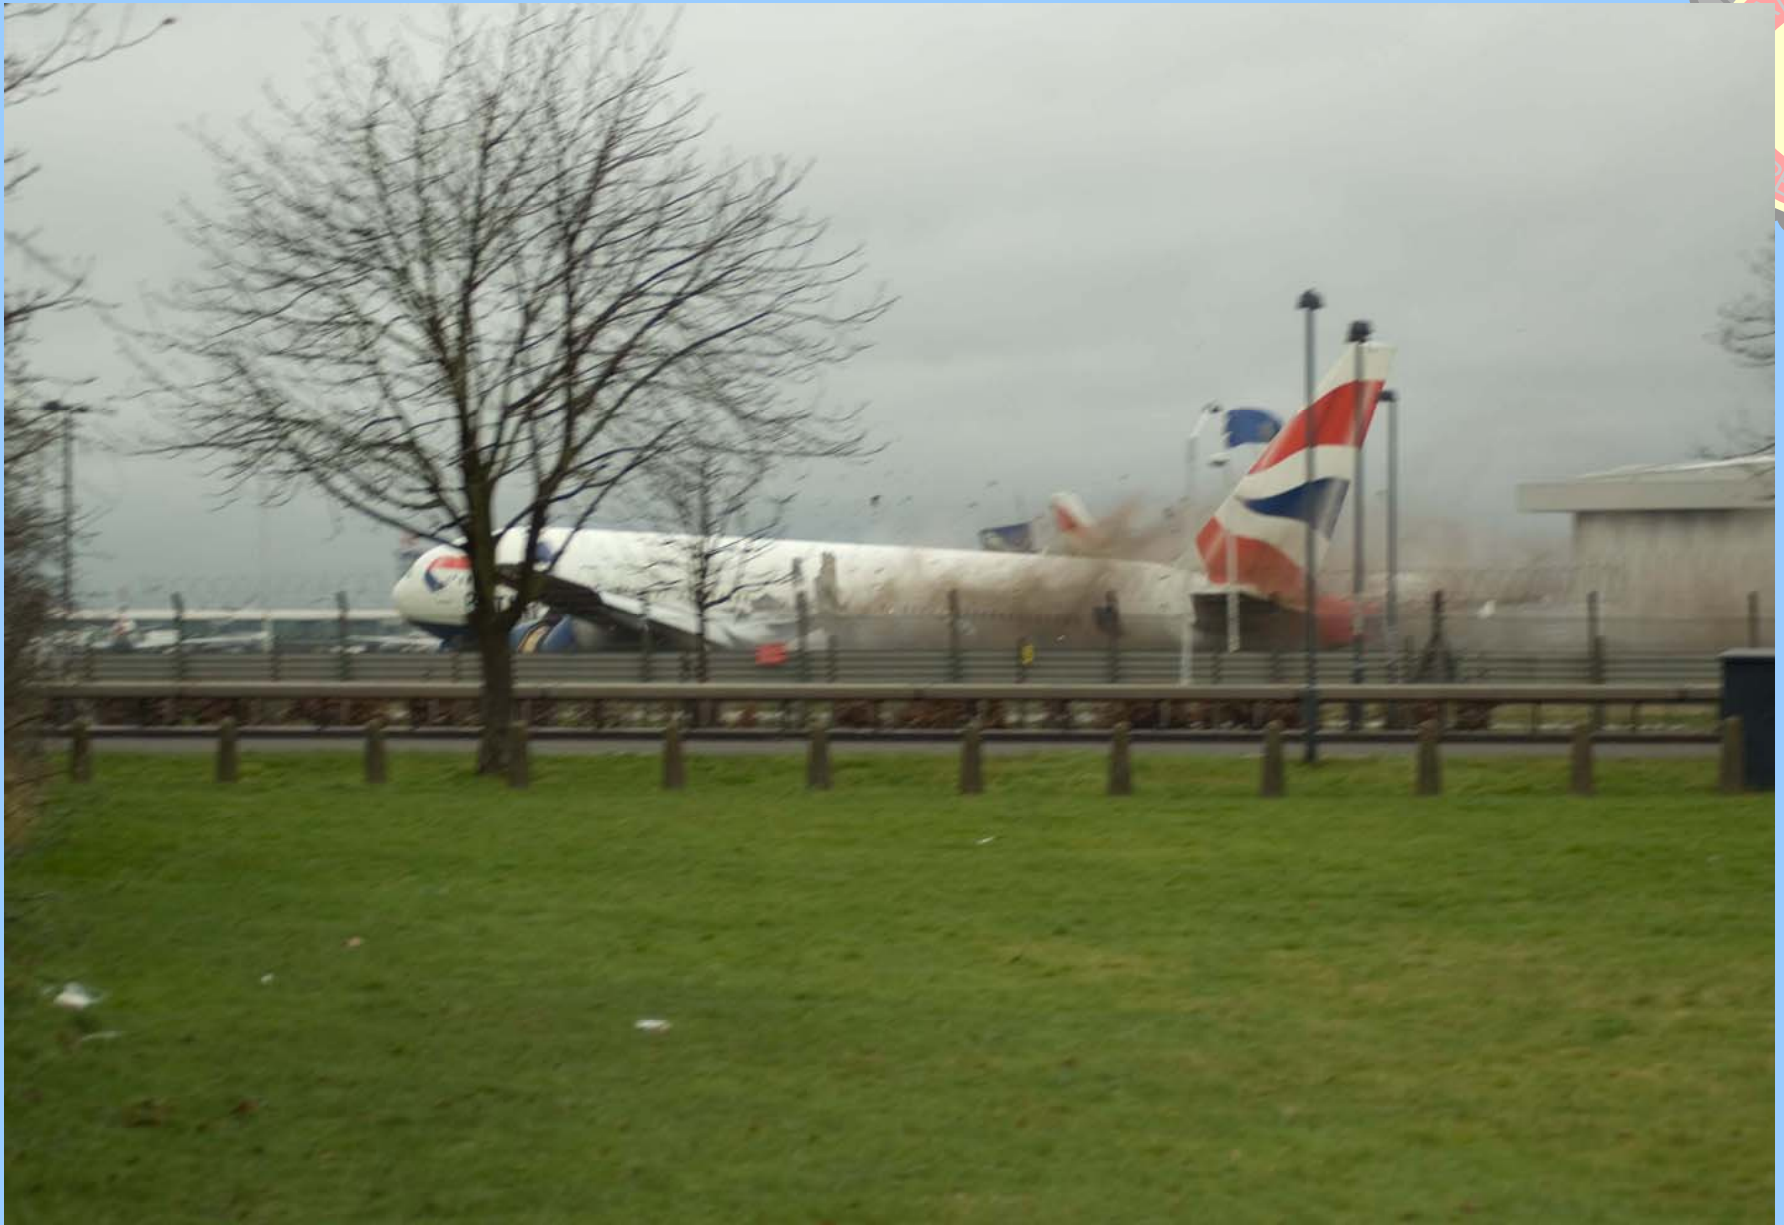
During the impact and short ground roll the nose gear collapsed.

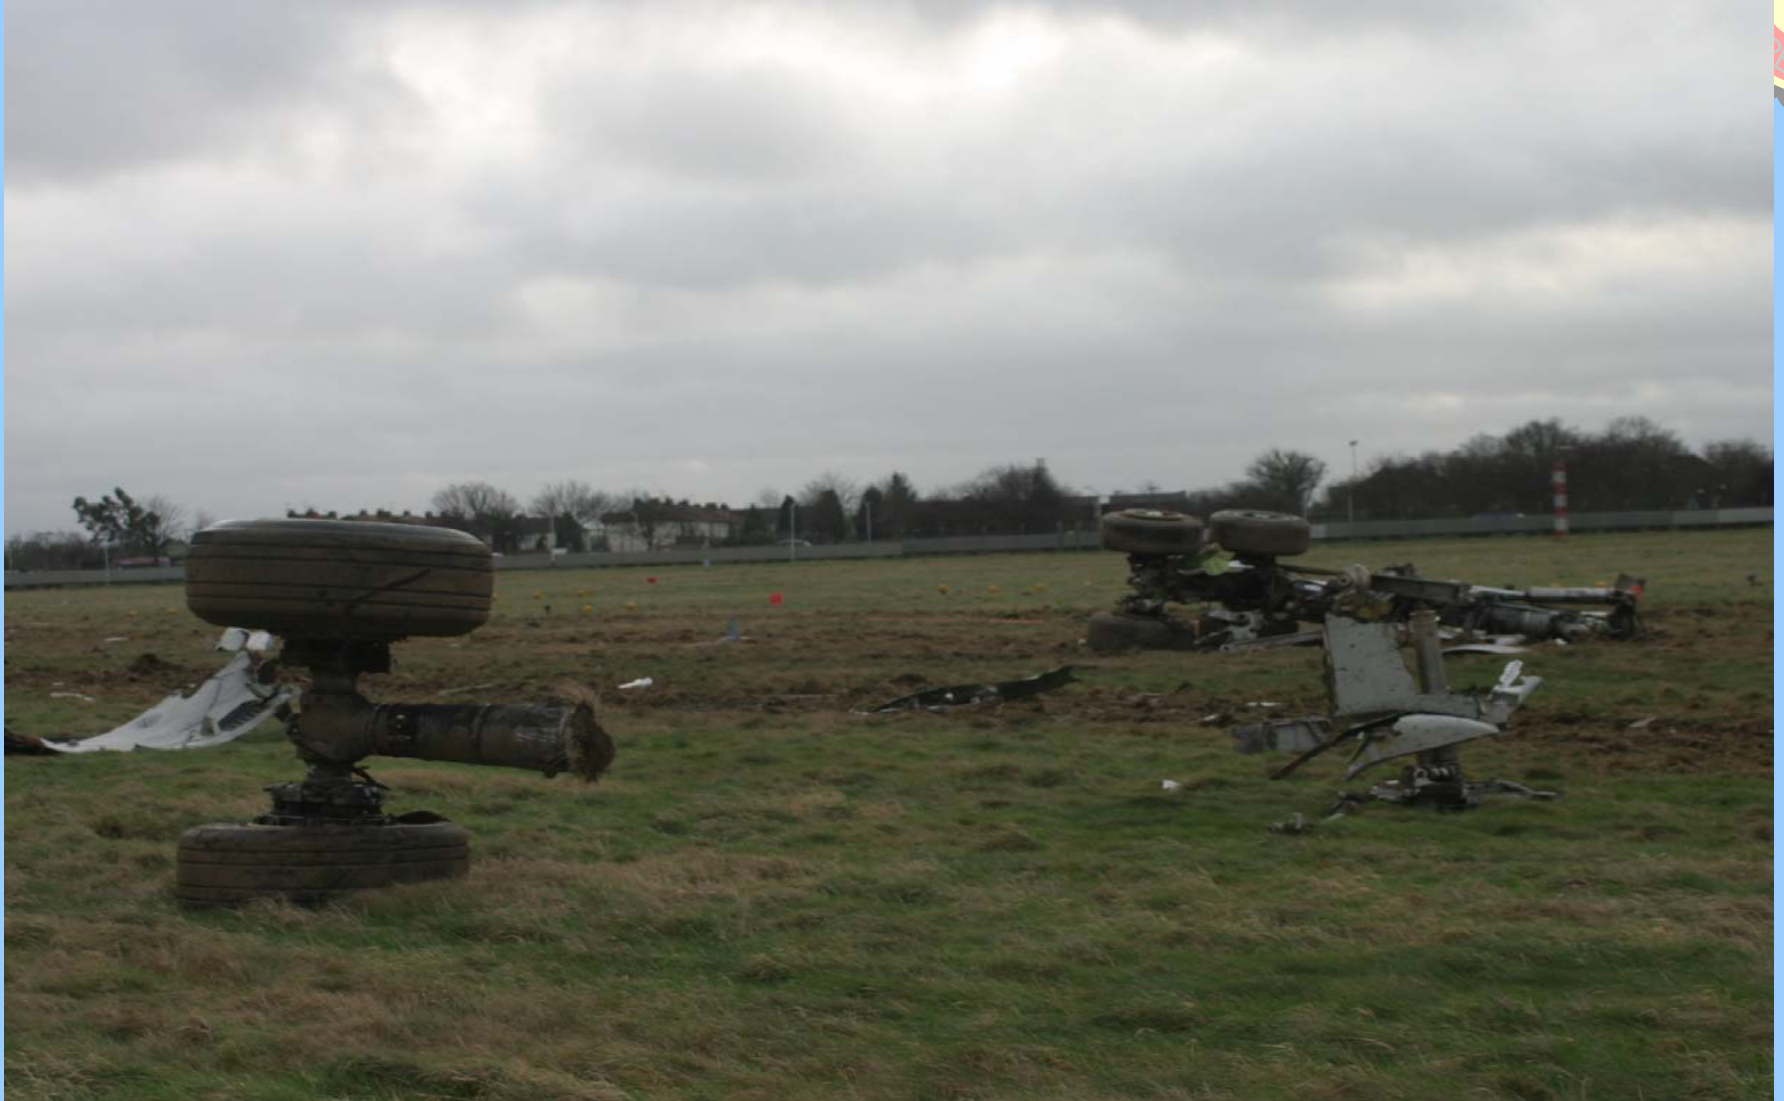
The right main landing gear separated from the aircraft breaking into two main pieces, one part of which struck the fuselage & horizontal stabiliser.

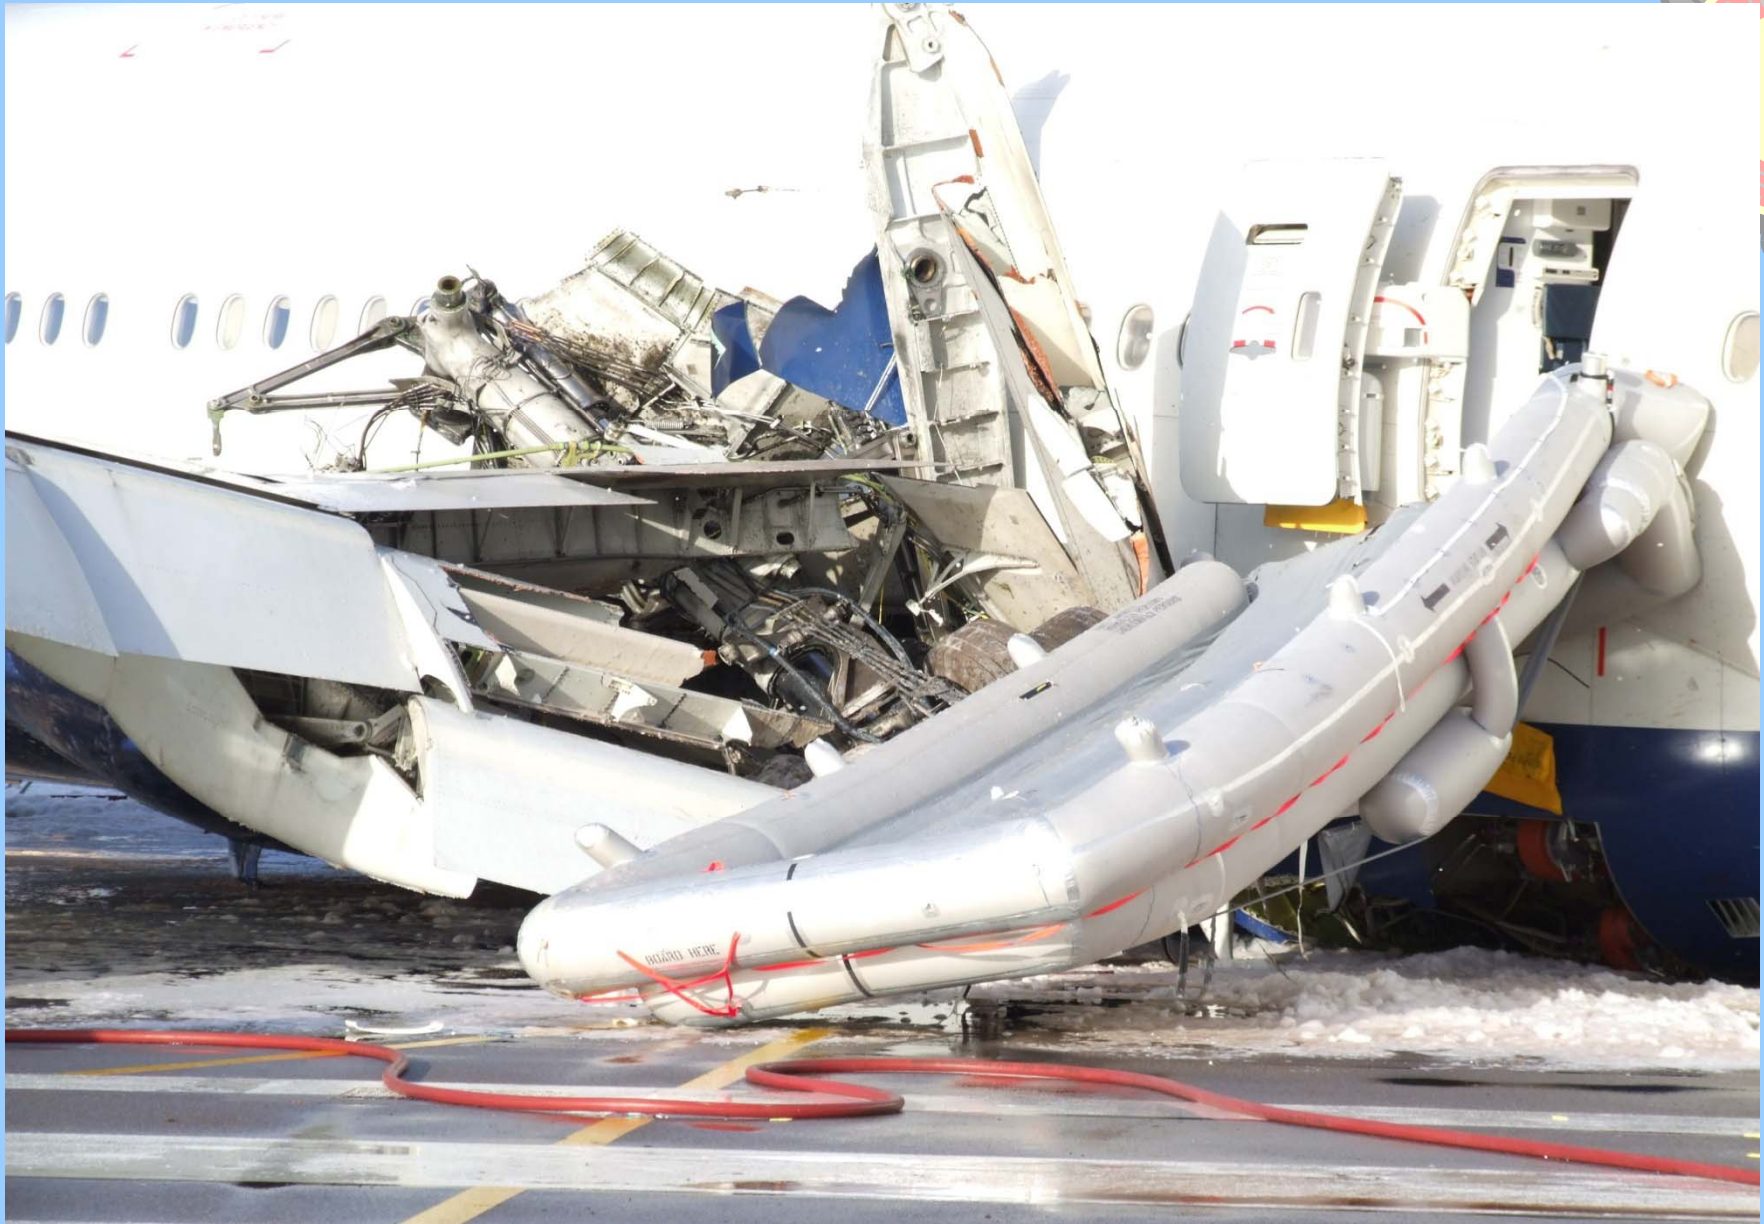
The left main landing gear was pushed up through the wing.

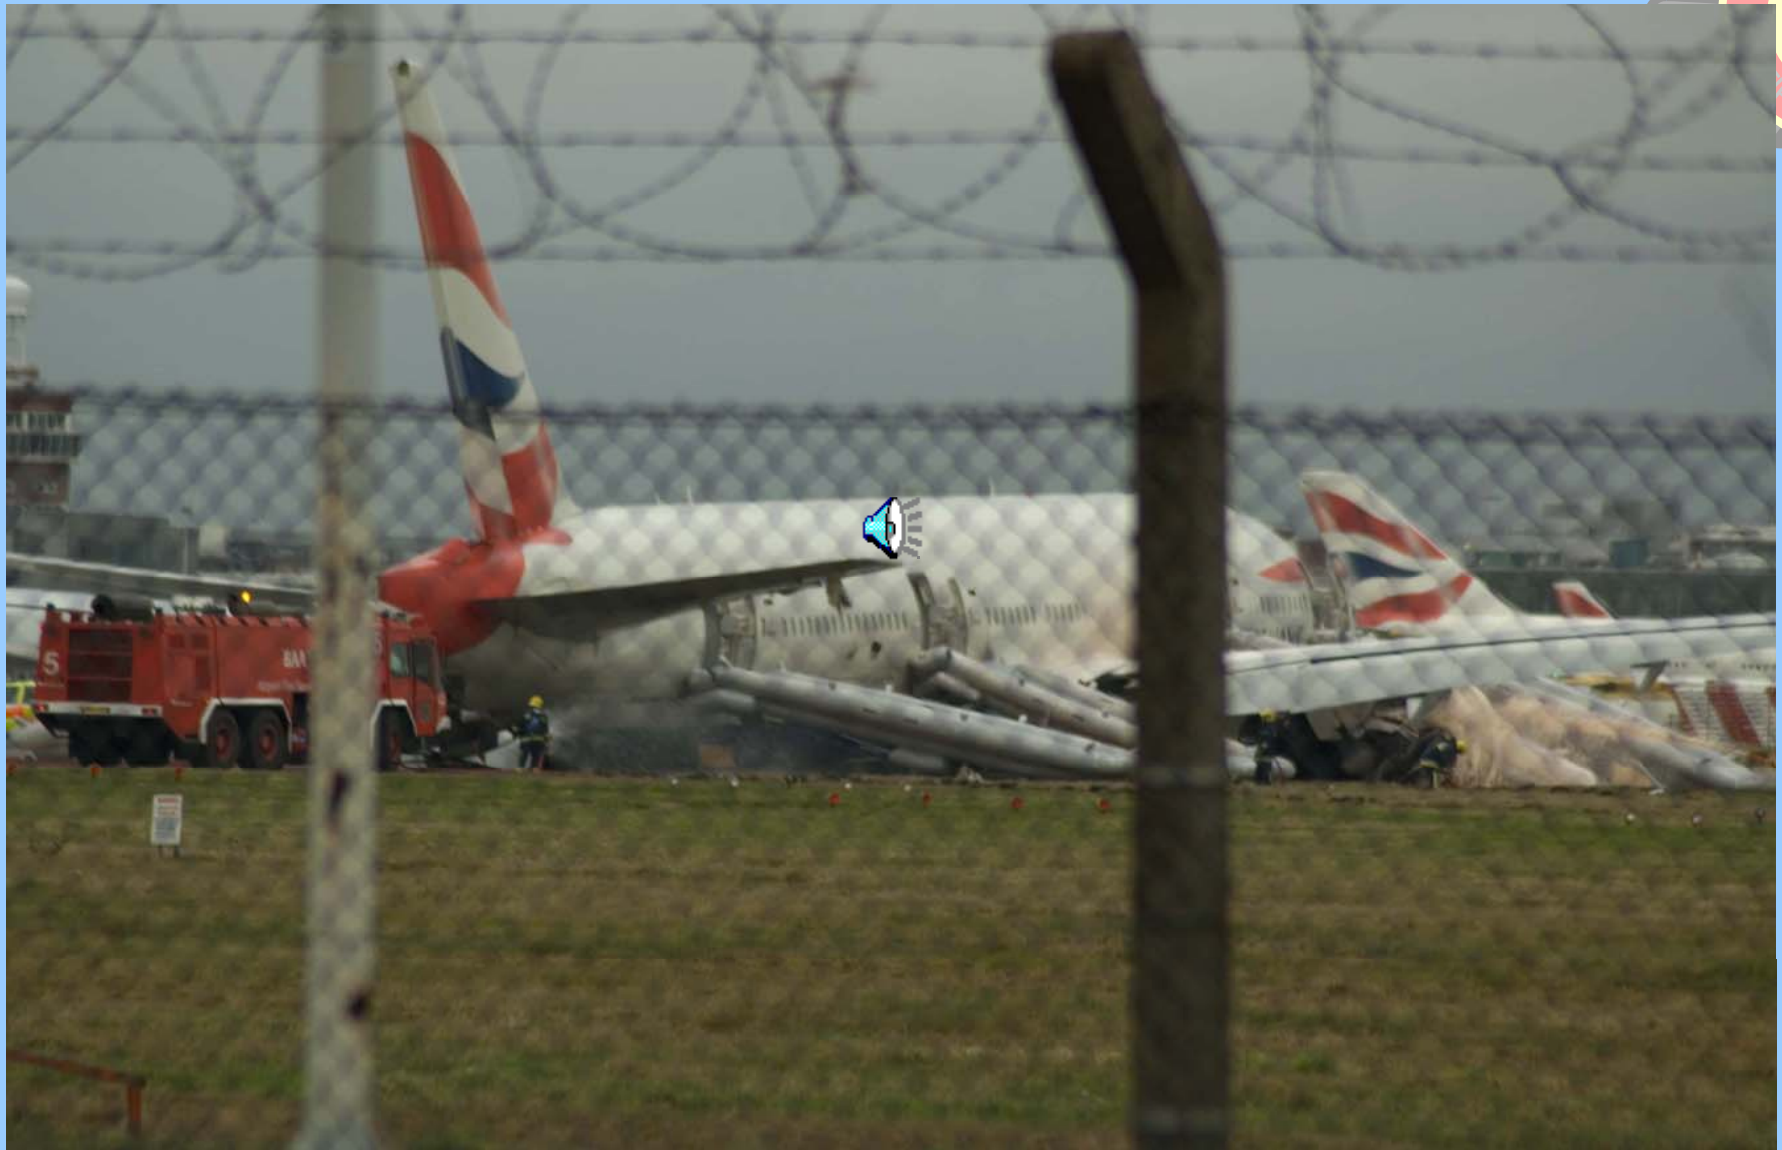
The Airport Fire Service were quickly on scene supported by Airfield Operations and Police who instigated survivor reception procedures.

The Airport Fire Service maintained readiness due to the ruptured rear right wall of the centre fuel tank caused when the right main landing gear separated from the aircraft.

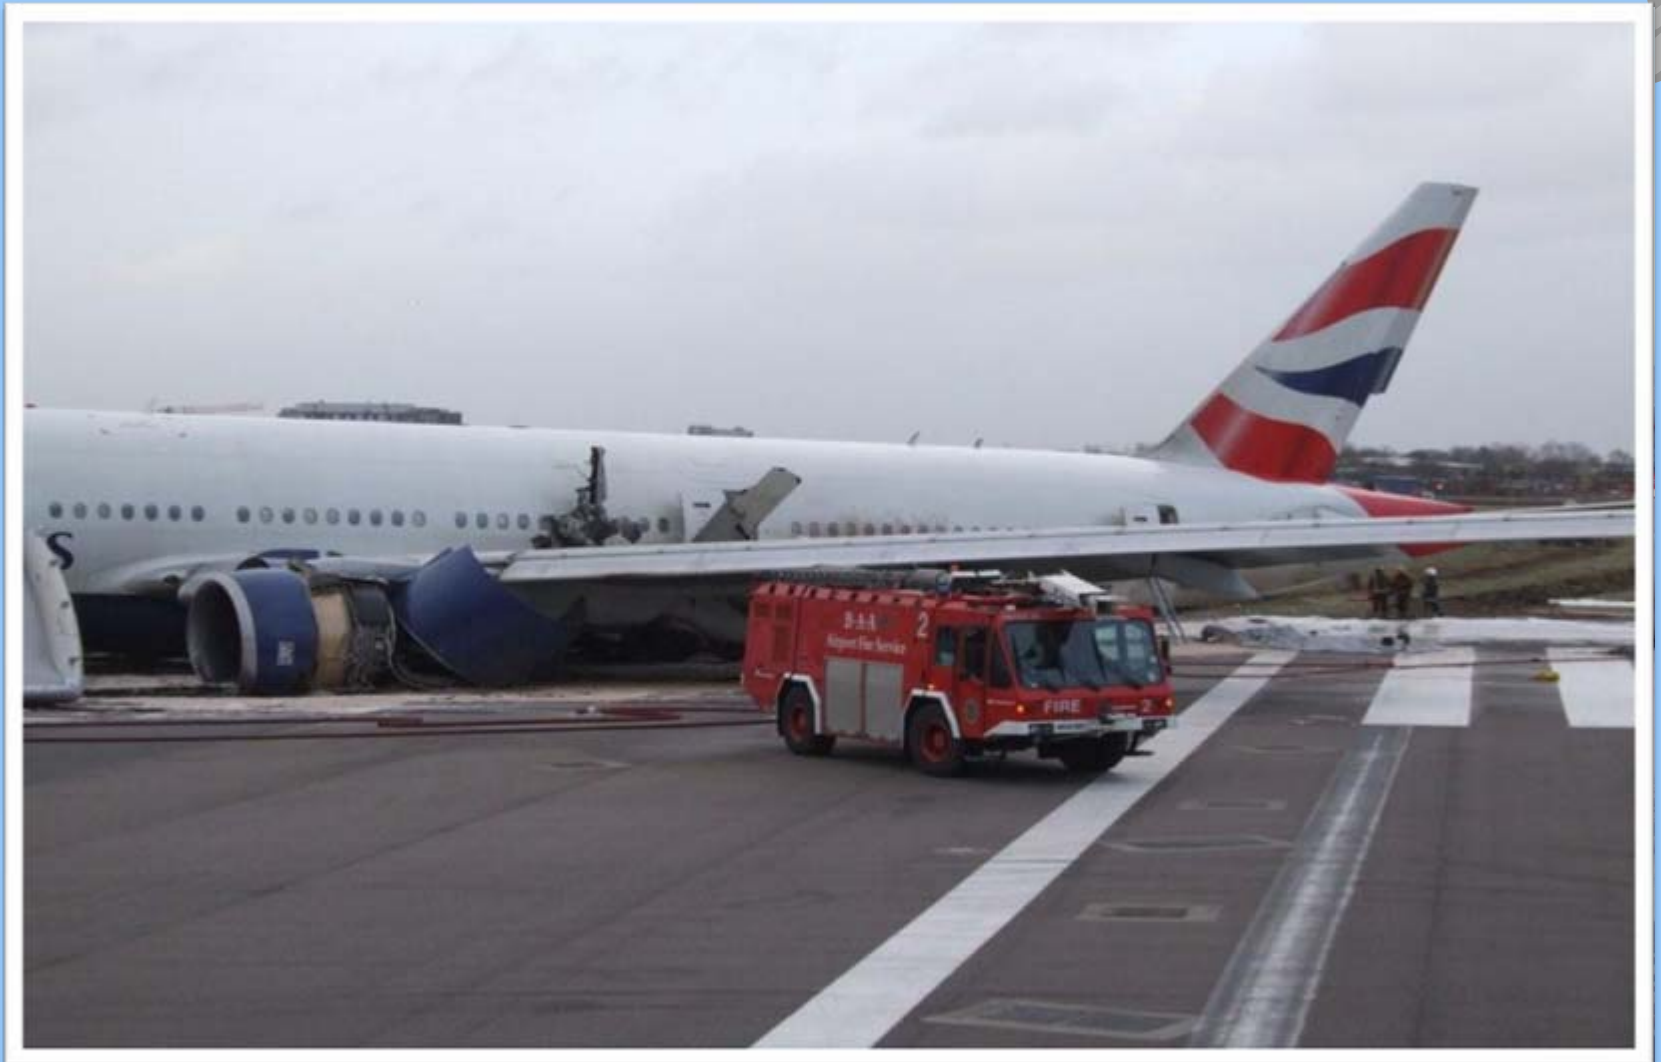
The aircraft's engines were of primary concern for the investigation and had sustained significant damage in the crash with the weight of the aircraft supported on them. The right had obvious damage.

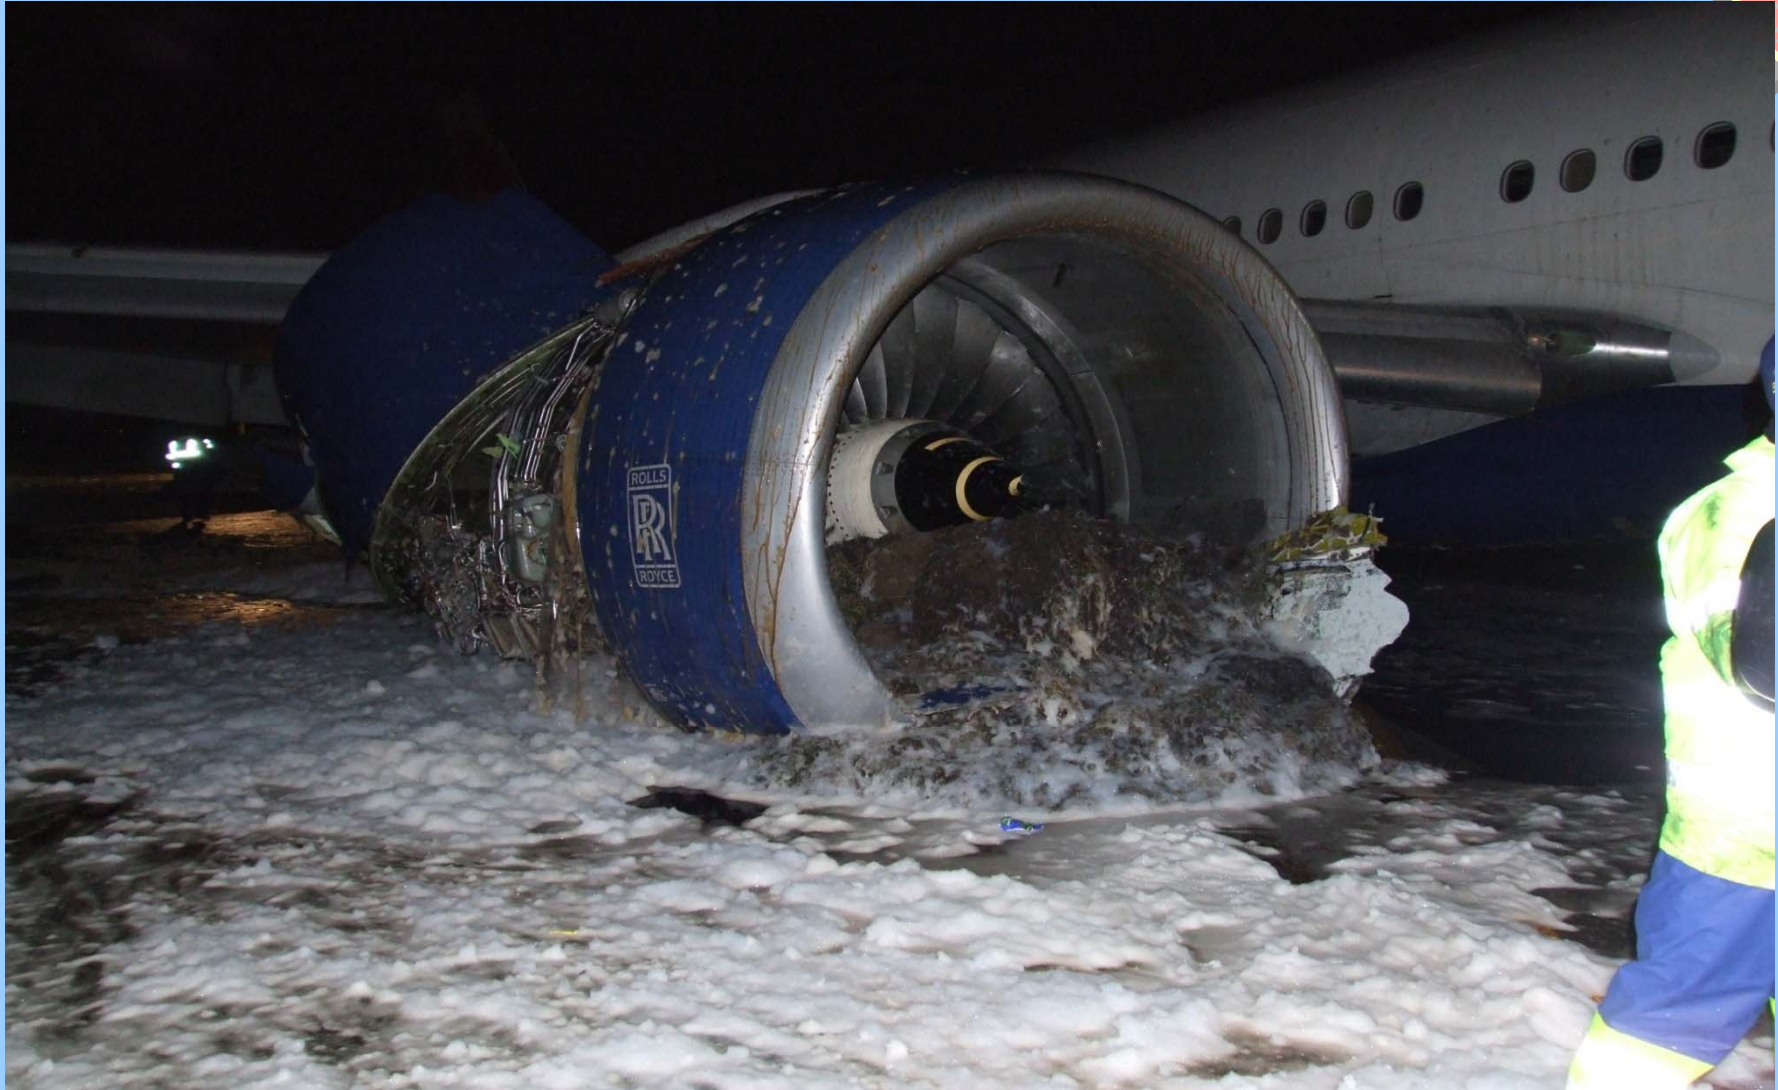
There was a significant debris field that would require professional examination and recovery.

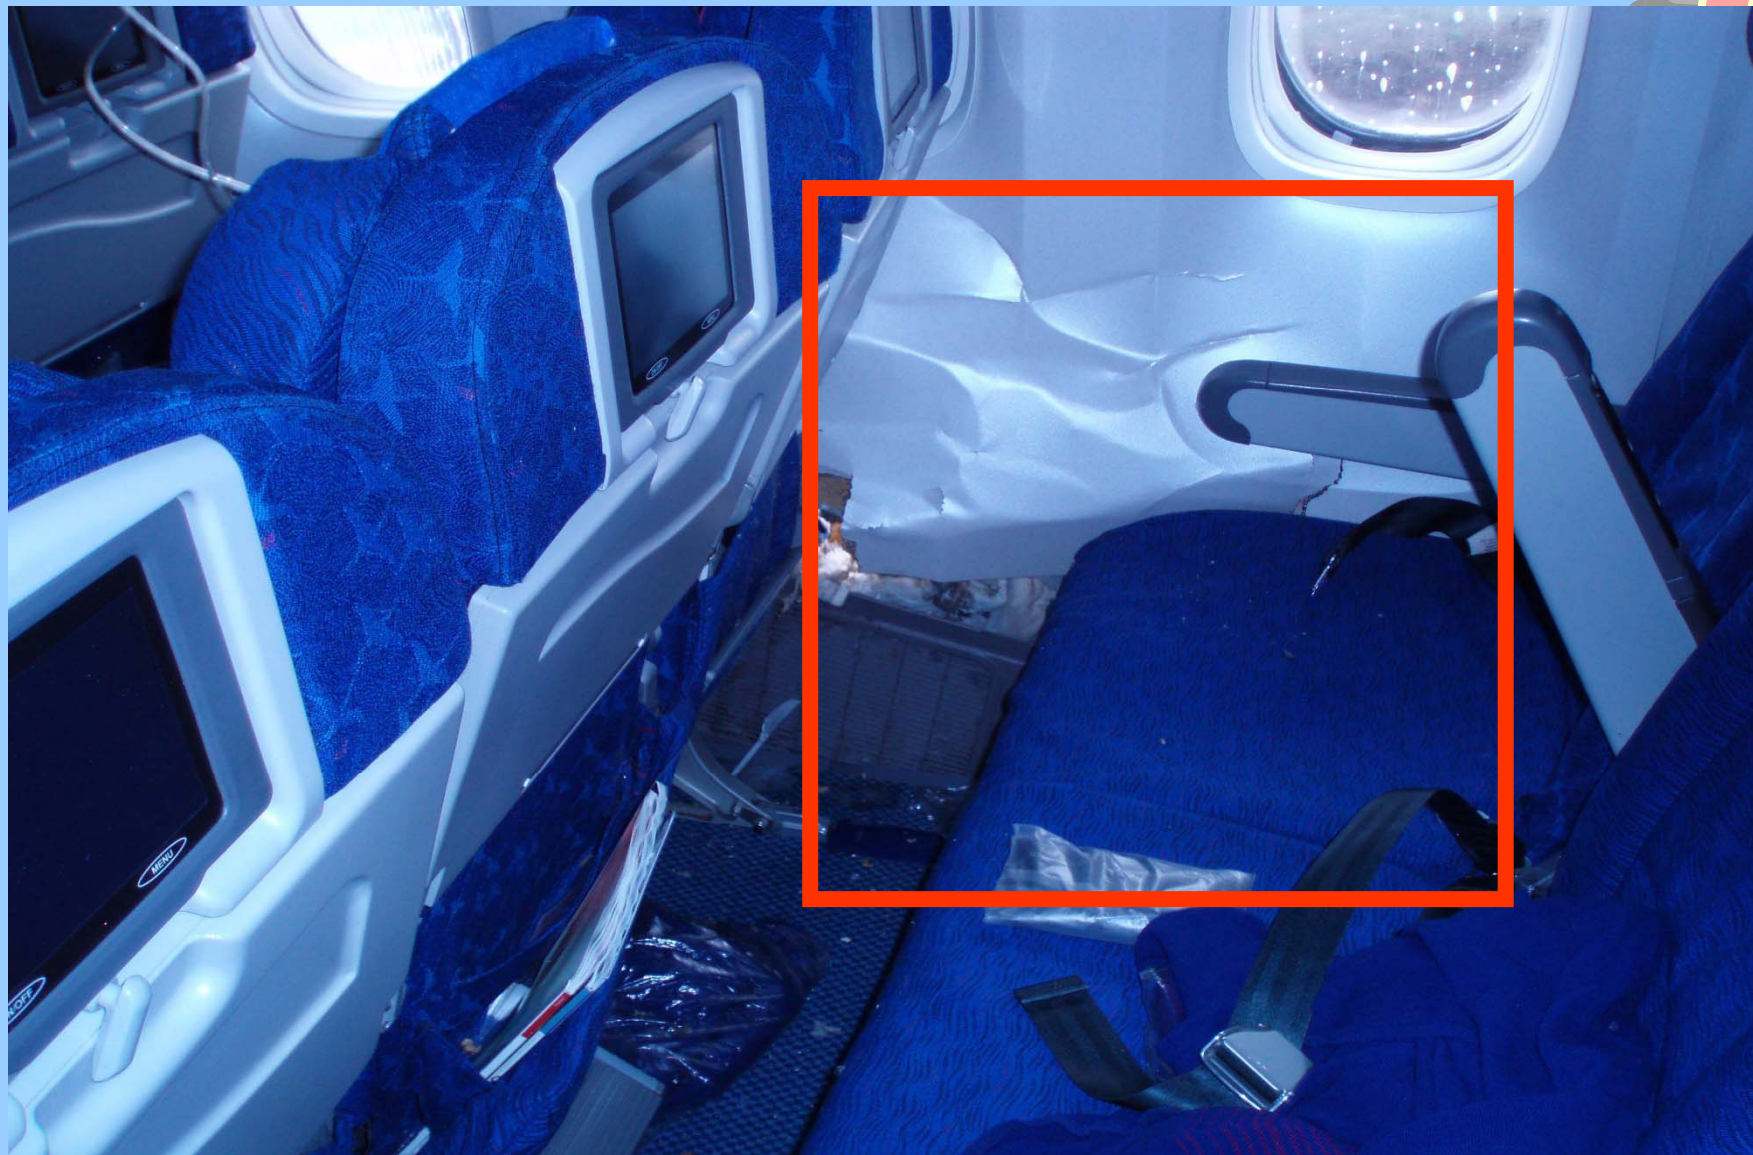
The only visible compromise in the cabins integrity was by Row 29 and Row 30 adjacent to seat K.
